London's Swifts

Roof Repairs & Re-Roofing with Swifts

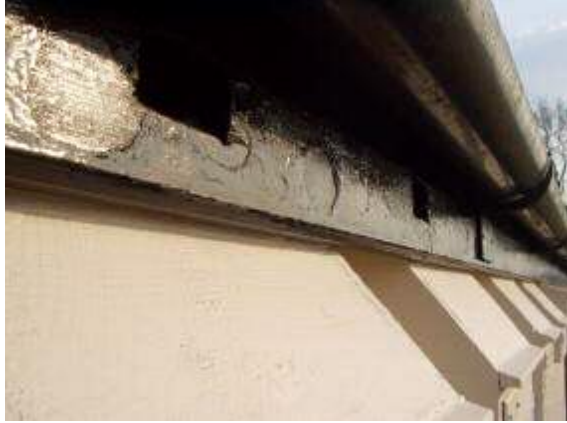
Holes cut in the facing boards let the Swifts reach their nests in the eaves of this chapel
Photo © Mark Glanville

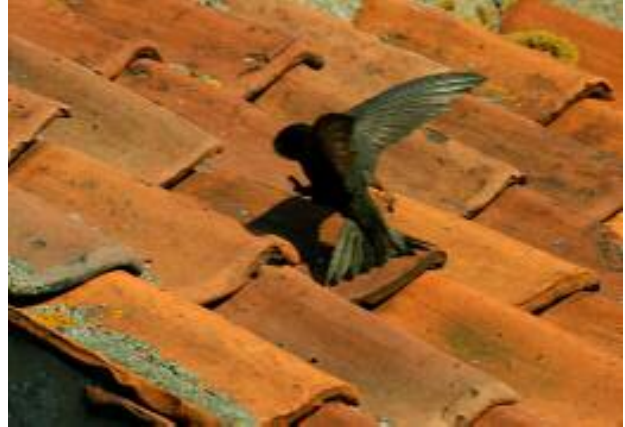
A Swift entering a roof via a displaced pantile. The nest is on the roofing felt below
Photo © Bill Ball

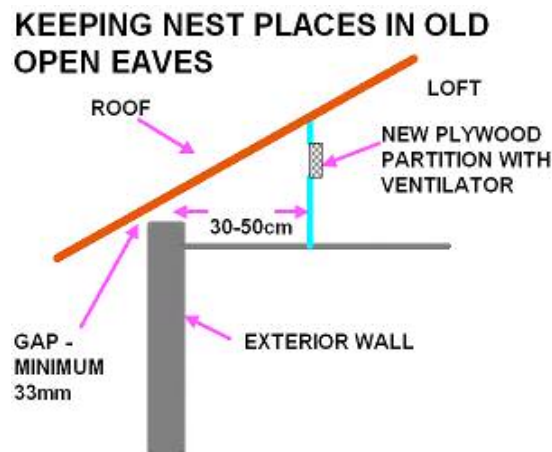
If you have to, install a ventilated plywood partition at least 30cm inside the loft to enclose the Swift nest areas and make the loft area usable, as shown below.

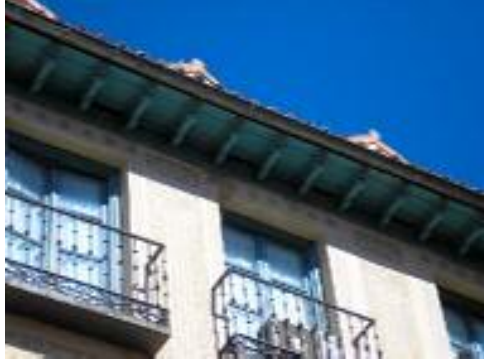
Swifts breed inside the eaves of this hotel at the Escorial, in Spain. Access slots (seen as dark lines at the top of the wall) are left free for them to enter and also to ventilate the roof space.

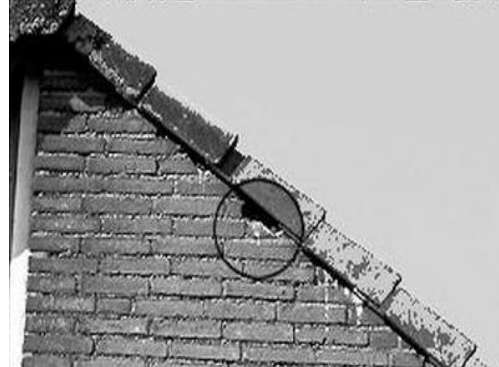
Swifts nest under the tiles on the brick ends of this roof. Repairs would evict them, but leaving the bricks as they are and fitting deeper tiles, offset to maintain the Swifts' access from below, will provide weather proofing and still let the Swifts nest.

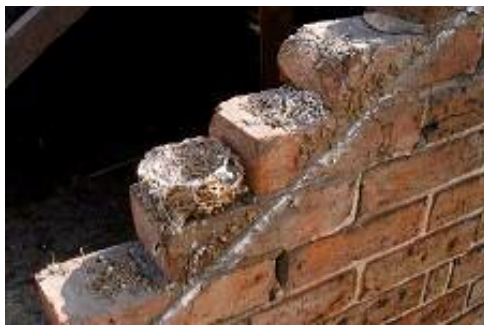
A Swift nest on a gable brick end, exposed when the barge boards were removed. Swifts can nest in very restricted places.

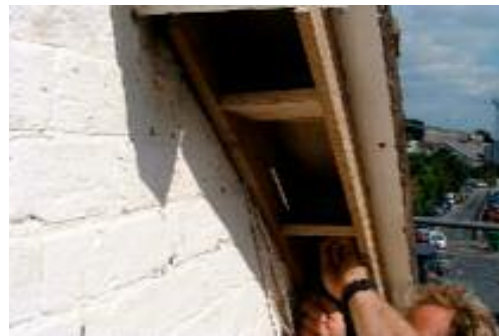
The gable brick ends shown exposed on the left have been fitted with bargeboards containing staircase type nest boxes. These will be faced with a plank with entrance holes cut for the Swifts to access the new nest places inside.

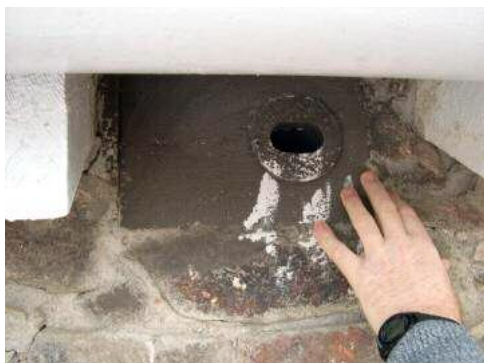
A Schwegler "Swift Brick" inserted into previously open eaves to provide a replacement Swift nesting place. The roof of this NHS hospital had to be sealed to meet hygiene requirements, but the Swifts' nests were saved.

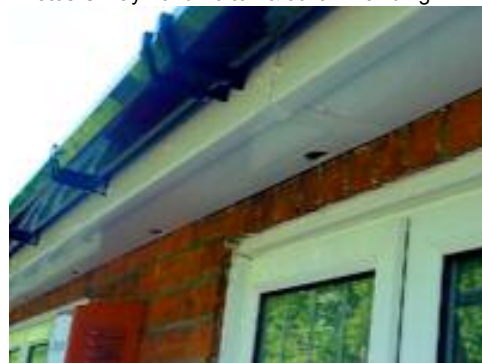
Plastic soffits and gutters have been fitted to this re-roofed house. Holes have been cut in the soffits close to the wall to provide access for the Swifts to their nests in the eaves.
